## Conestoga-Rovers & Associates Project Summary

### PIPE RACK IMPROVEMENT PROJECT MEMPHIS, TENNESSEE

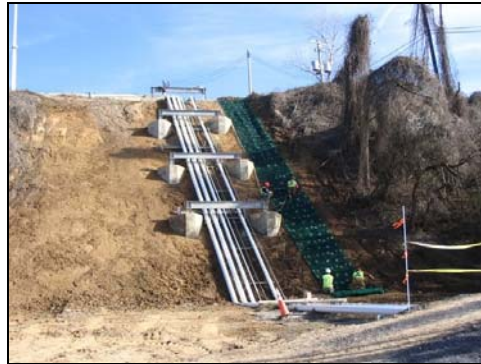
CRA was retained to provide a complete turnkey design/build project to construct a new pipe rack that would replace an existing one at a large petroleum terminal in Memphis, Tennessee. The existing pipe rack extended down a 1.3:1 slope from a tank farm. The foundation system consisted of below grade concrete footers that were being undermined by a failing slope. The pipe rack supplied fuel to the terminal's loading rack. The new pipe rack was to be constructed while maintaining service to the loading rack.

The work included the complete geotechnical and structural design and implementation of the design to improve the foundation system. Design elements included geotechnical analysis to evaluate the effectiveness of small diameter piles that would support the new steel columns and beams. In addition, a structural analysis was completed to size the concrete pile caps and steel columns and beams. Once the analysis was complete, CRA specified four sets of foundations that included three helical piles per foundation. The specified capacity of the helical piles was 10 kips each and these were installed to a depth of 10 feet. CRA specified 4,000 psi concrete for the pile caps, W8x21 steel columns, and W14x38 steel beams.

- Access road construction
- Clearing of brush, small trees, and kudzu from the work area
- Slope reconstruction with compacted clay fill
- Installation of helical piles
- Concrete pile cap construction
- Erection of the steel columns and beams
- Secure the existing pipes to the new rack with pipe clamps

The field work was particularly challenging in that the majority of the activity was done on the 1.3:1 slope. This made safety, specifically fall protection, very important. All work on the slope was completed with harnesses that were securely tied off at the top of the slope. The work was completed within a 2-month timeframe without incident.
