# Conestoga-Rovers & Associates Project Summary

## BNSF TRAIN DERAILMENT RESPONSE CRAWFORD, TEXAS

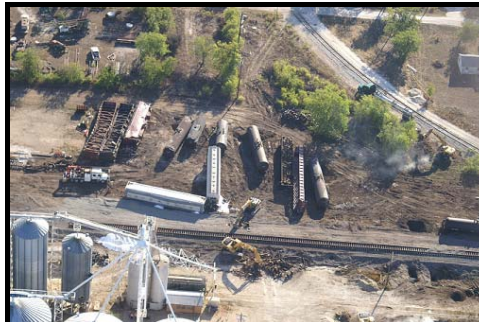
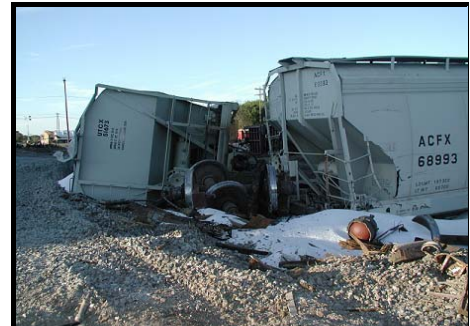
In September 2006, CRA was retained to provide spill response management, regulatory liaison, site assessment, and closure reporting for a twenty-four railcar derailment near downtown Crawford, Texas. Fourteen empty railcars derailed and were in a pileup along the BNSF right-of-way (ROW). Eleven railcars containing a variety of solid and liquid materials derailed, but did not leak. Two railcars released plastic pellets during the derailment and were piled along the BNSF ROW. One railcar containing styrene did not leak during the derailment, but released an estimated 5 to 10 gallons of product into the soil during re-railing activities.

A single railcar, containing an ethanolamine mixture, derailed and resulted in the loss of approximately 22,000 gallons of product. The released material flowed through an existing concrete culvert and through a storm water drainage ditch for approximately 78 feet. Also, some railcars derailed onto a semi-tractor trailer that was parked adjacent to the BNSF ROW. The semi-tractor's diesel fuel tank was compromised releasing approximately 5 to 10 gallons of diesel fuel into the soil along the BNSF ROW.

- Collection of 16,740 gallons of ethanolamine mixture with vacuum trucks
- Washing of concrete culverts affected by the ethanolamine mixture and collection of the rinsate

- Coordination of the transportation and disposal of the collected ethanolamine mixture and rinsate
- Excavation of over 2,000 cubic yards of ethanolamine mixture affected soil

- Excavation of approximately 600 cubic yards of diesel fuel affected soil and 325 cubic yards of styrene affected soil
- Coordination of the transportation of diesel fuel affected soil, styrene affected soil, and ethanolamine mixture affected soil to an approved BNSF landfill

- Site restoration activities that consisted of backfilling and grading the site to pre-existing contours and hydro-mulching
- Report documentation of the diesel fuel release area, styrene release area, and the ethanolamine mixture release area
